Issue

The four (4) screws that hold the metal disc to the glass may come loose during operation. This procedure addresses the proper steps to re-tighten the sample tray, and to modify the software settings to prevent the reoccurrence of the issue.

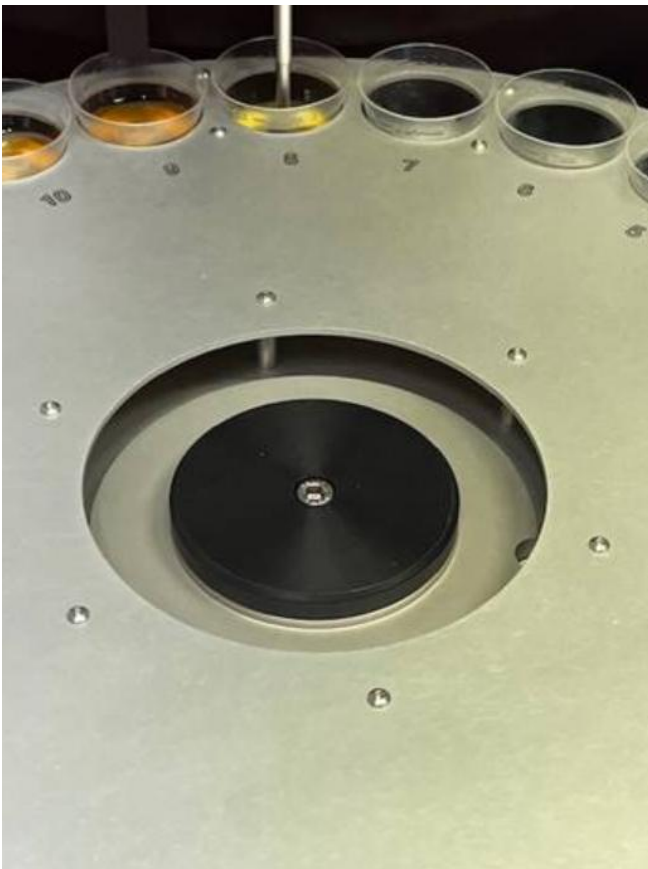
The CINRG CS-APC-22M sample tray showing the black acetal cap/cover.

The black acetal cap with one hex socket screw doesn't have a functional purpose. It just covers the 4x #10-32 Hex socket head screws that need to be tightened. To tighten the sample tray:

1. Remove the sample tray.
2. Using the CINRG software's testing panel, send 'Reset carousel '.
3. Once the carousel resets and is at position 1, close the software and turn off the instrument.

4. Remove the 1x metric hex socket screw holding the black acetal cap/cover.
5. Now check how tight the 4x #10-32 screws that hold the metal disc to the glass. It should neither be too tight nor be too loose. Must be finger tight (slightly more than it).

6. There is an 'o'-ring beneath the metal piece that presses against the glass while you tighten it. While you do the step 5, check if the 'o'-ring did not move from its groove (underside of the metal disc).

7. Once you reinstall/tighten the metal disc, do not install the black cap (we can install later when we confirm the issue is resolved- till then we may need access to those 4x screws)

8. Turn on power to the instrument
9. Open CINRG software and head to the testing panel. Click reset carousel. Also input several sample positions and see how the unit performs.

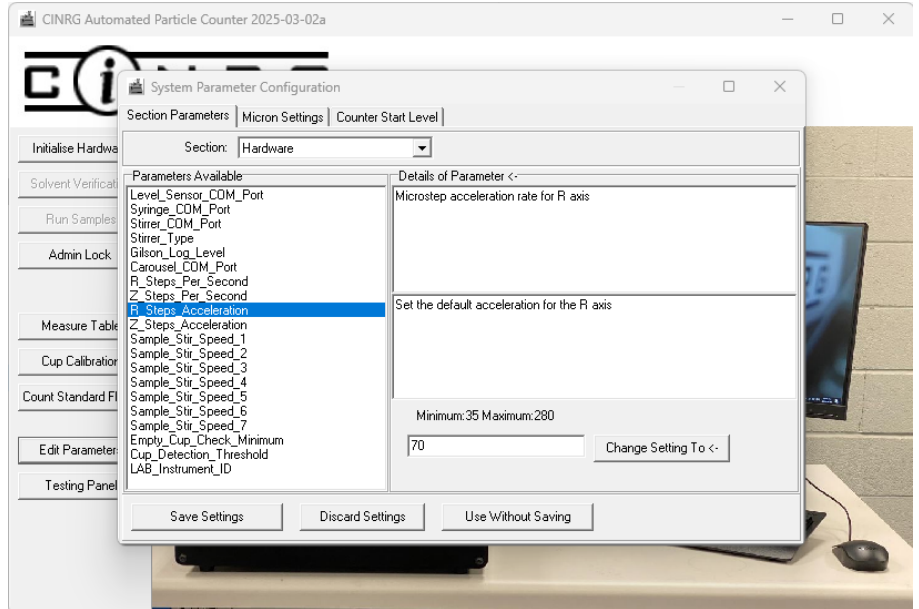
Figure 1 – The Section Parameters tab of the Edit Parameters dialog showing the hardware settings.

If the tray is coming loose repeatedly, it may be necessary to lower the speed of the rotary drive. This can be accomplished through the CS-APC-22M instrument software.

1. Launch the instrument software in admin mode.
2. Click the [Edit Parameters] button from the admin menu.
3. From the Section Parameters tab select the Hardware section (see Figure 1).
4. Set R_Steps_Per_Second to 50000.
5. Set R_Steps_Acceleration to 35.
6. Click Save Settings and close the System Panel Configuration dialog.

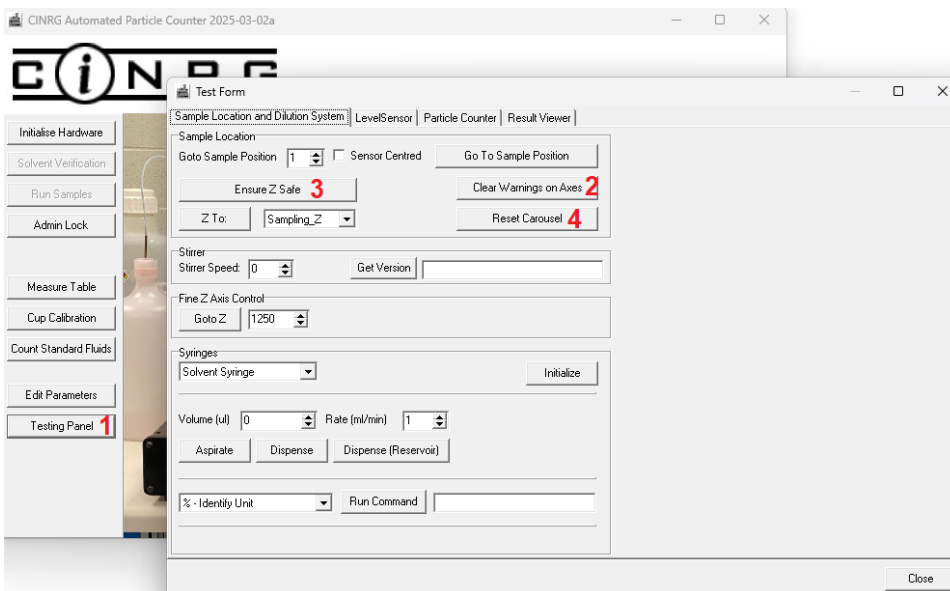
Figure 2 – The Sample Location and Dilution System tab of the Testing Panel dialog.

You may need to perform an instrument re-set after encountering any motion related errors from Zaber 'Z' axis drive or the Rotary drive. You can use the testing panel to clear out the errors to resume operation.

1. Click on the [Testing Panel] button from the admin menu (labelled “1” in Figure 2).
2. Click on the [Clear Warnings on Axes] button (labelled “2” in Figure 2).
3. Click on the [Ensure Z Safe] button (labelled “3” in Figure 2).
4. Click on the [Reset Carousel] button (labelled “4” in Figure 2).
